# Porsche 997 Ash Tray Paint Repair

This guide will show you how to repair a very common issue among 997 and 987 owners. The interior plastic paint tends to peel around the ash tray (and other areas) We will remove the original coating and then proceed to repaint the affected area.

Written By: DriveDIY

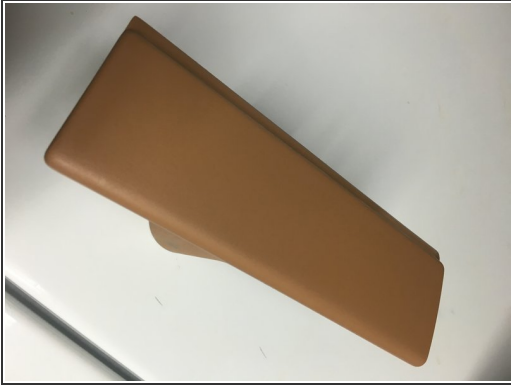
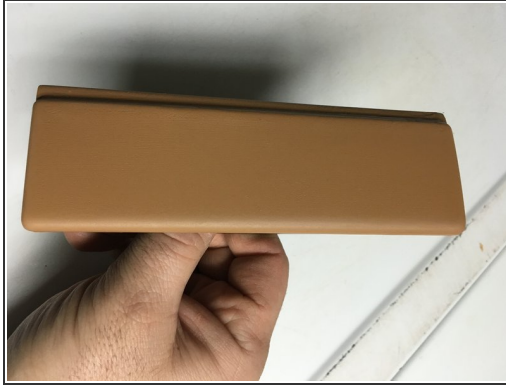
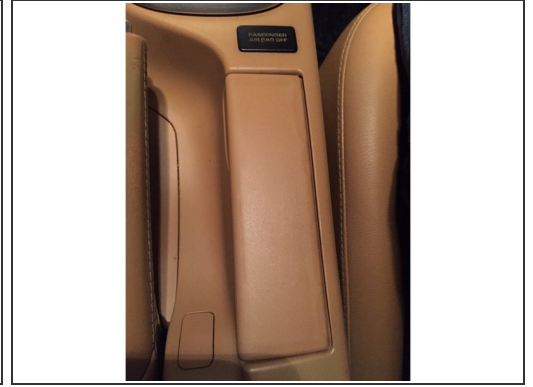
## Step 7 — All Done

- Color Match is perfect !

Ignore bright spots around the edge of plastic... paint was not fully dried at this point.
