# Porsche 987 Ash Tray Paint Repair

This guide will show you how to repair a very common issue among 997 and 987 owners. The interior plastic paint tends to peel around the ash tray (and other areas) We will remove the original coating and then proceed to repaint the effected area.[summa

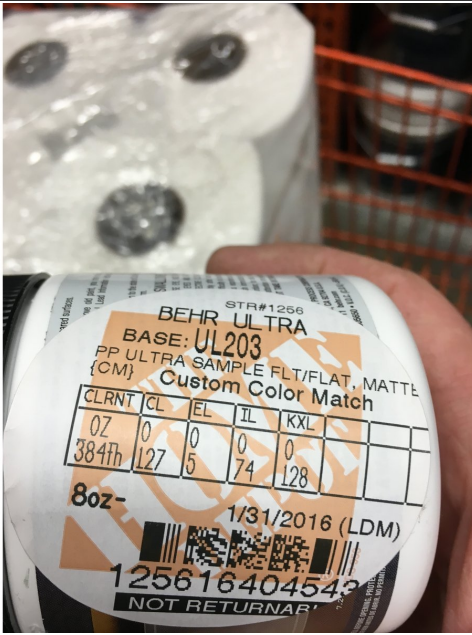
## Step 1 — Porsche 987 Ash Tray Paint Repair

- Ask home depot paint rep to mix a sample of 697912143052 for Sand Beige Interior
