# Porsche 987 Ash Tray Paint Repair

This guide will show you how to repair a very common issue among 997 and 987 owners. The interior plastic paint tends to peel around the ash tray (and other areas) We will remove the original coating and then proceed to repaint the effected area.[summa

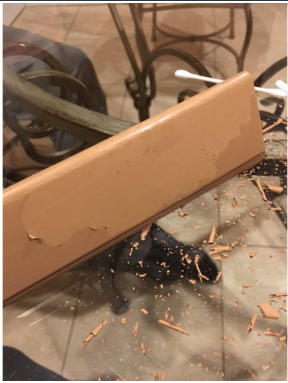
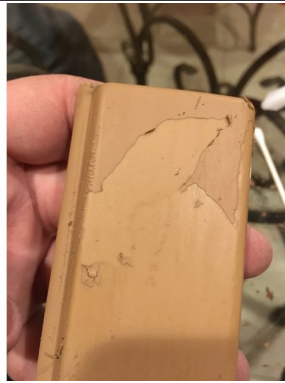
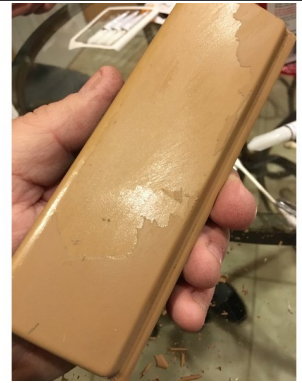
## Step 2

- Apply Lacquer thinner and begin to remove paint.
- The paint will softened and being to bubble up , just keep working the paint with lacquer thinner till its all off.

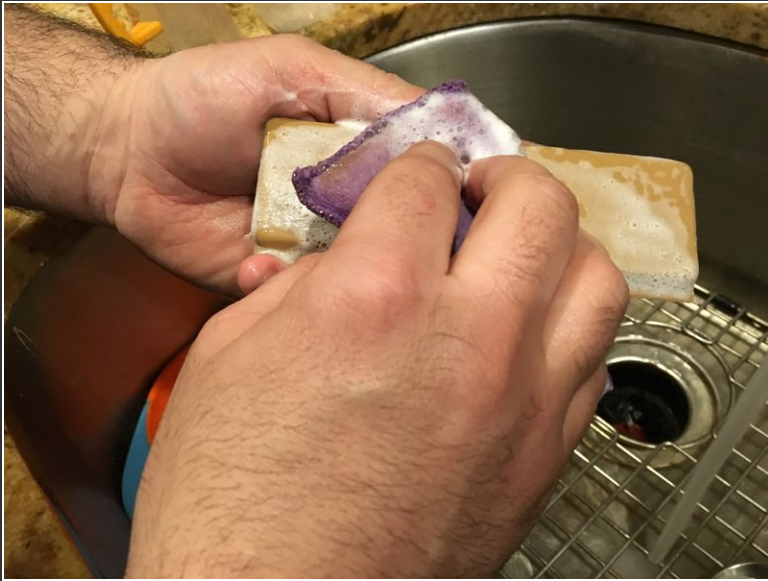
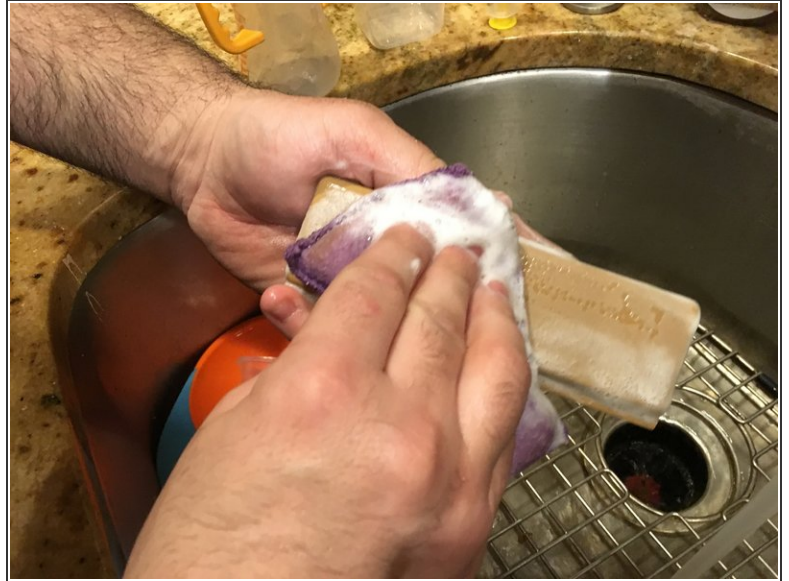
### Step 3

- Wash the plastic piece with some dishwasher soap to remove any residue

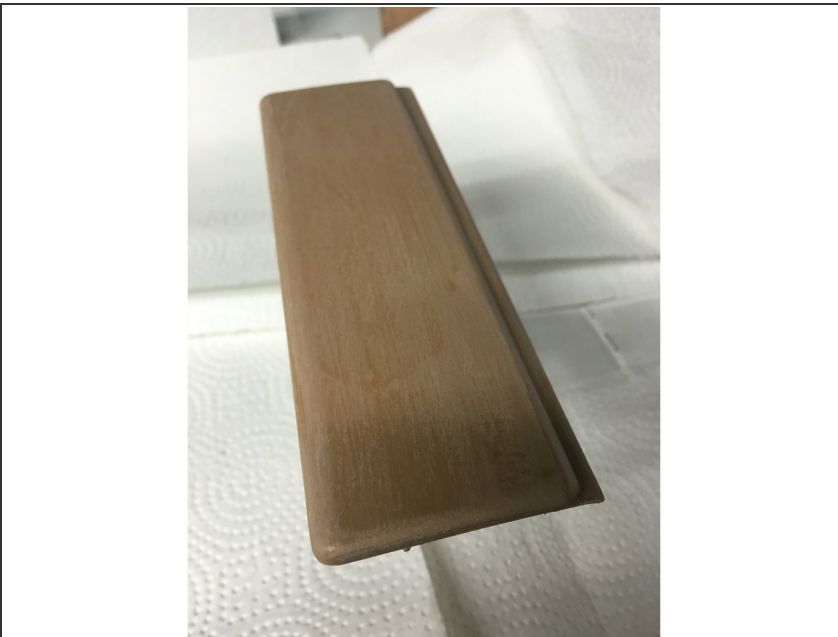
### Step 4

- ① I sanded the part lightly with some fine sand paper to remove any imperfections in the plastic

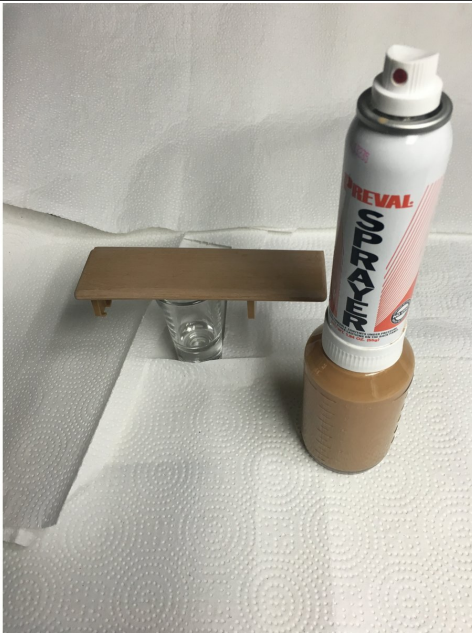
## Step 5 — Prepare Paint Area

- This is water based paint, so clean up is relatively simple... just lay down some newspaper or towel to protect the work area.

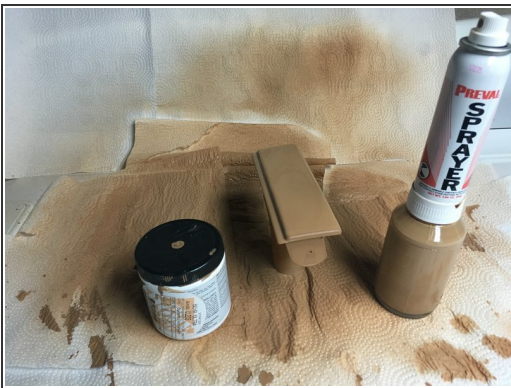
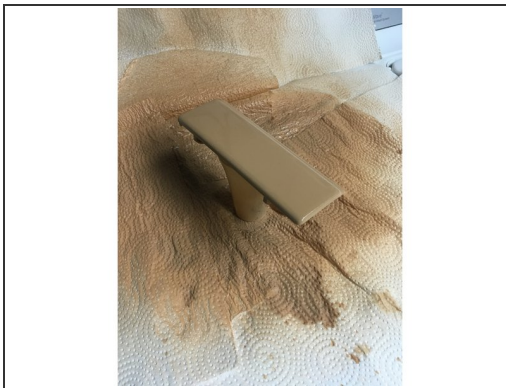
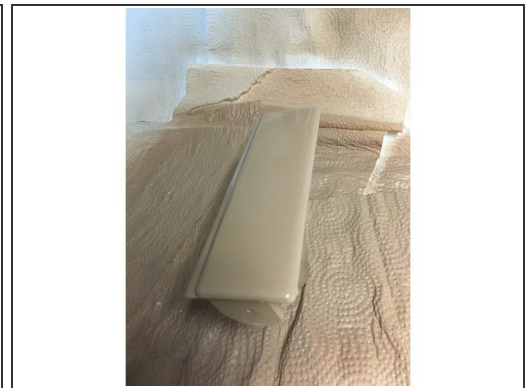
## Step 6

- Mix the Latex paint 3 parts paint : 2 parts water inside the Preval Sprayer
- Lay down even coats of paint on the trim piece.
- When spraying, never start or stop on the trim piece... always over spray it slightly.
- I laid down 2 thin coats and the part looked great.
- Let Dry And reassemble ash tray
